T1 REPORT

10 Horse Farm Drive, Clifton VA 20124.

Colonial Style Home. Approximately 2347 Sq. Ft. 29 Years Old; 2 Stories with finished basement apartment. 3 Car Garage. Swimming Pool.

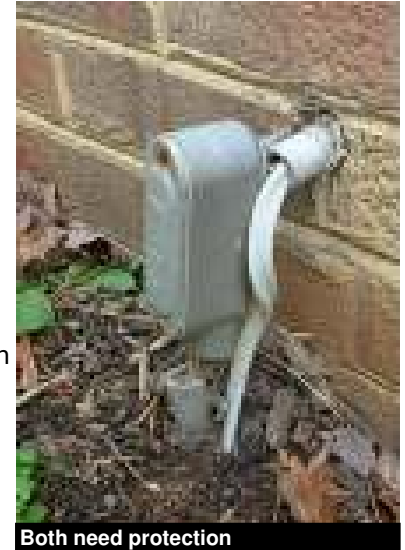
[SC] Safety Concern The conduit enclosing the 240V pool equipment conductors was broken exposing those wires to possible mechanical damage. The UF cable next to it also needs to be protected where it comes out of the ground. (See report photo)

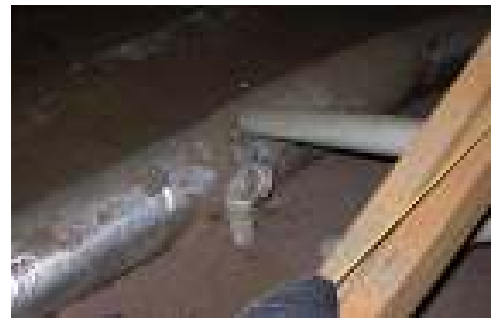
[CR] Corrections Recommended A white PVC vent piping connection in the attic had come undone. See report photo in the attic section of this report. We recommend having a plumber make repairs both to stop sewer gases from entering the attic, and to prevent rain from entering the exterior opening and draining into the attic.

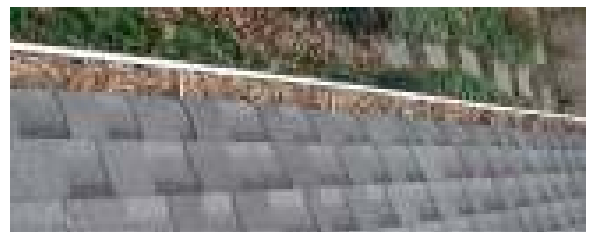
[MR] **Maintenance Reminder** The gutters were filled with debris which restricts proper drainage. We recommend correcting this condition. (Number one cause of moisture related issues in basements!)

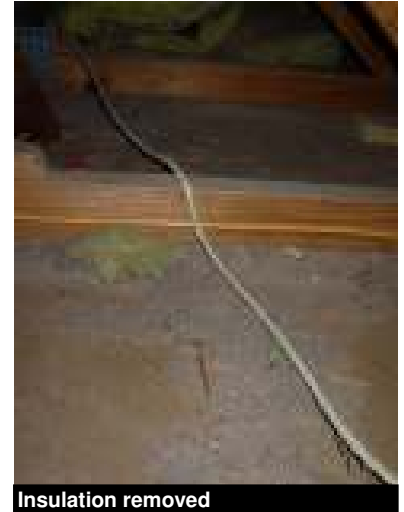
Much of the attic area sharing common walls with the house were insulated (new fiberglass). A small section was found with no insulation. We adding more insulation to complete the insulating barrier between this attic and the house.

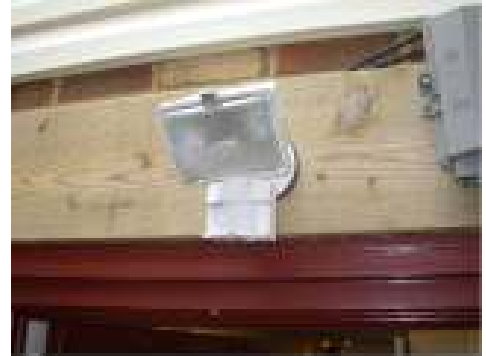
The stairwell light appeared to have photo-electric (light/dark) and motion detection properties. It did not light during the inspection. We recommend inquiring with the seller for more information about this light.

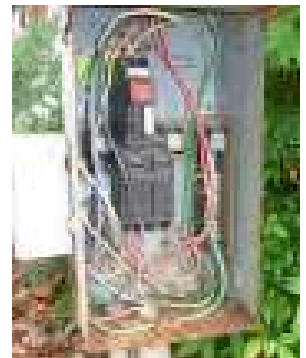
[SC] **Safety Concern** The electrical box shown in the picture is deteriorating and missing its deadfront cover so that live wiring/lugs are exposed to the touch. We recommend installing a cover or replacing the box.

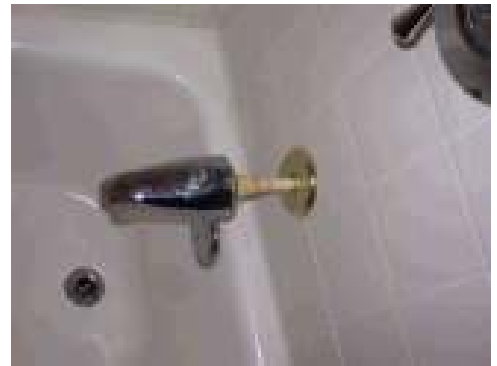
[CR] **Corrections Recommended** The tub and shower plumbing were functional, but as you can see in the photograph, the tub spout was not installed correctly (it should be flush to the wall). We recommend correcting this condition.

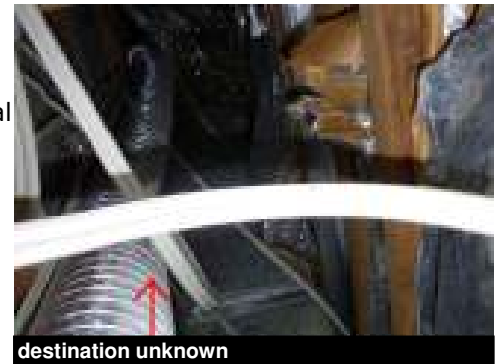
[CR] **Corrections Recommended** The dryer vent was routed in the wall with a flex-type material. The vent termination was not found or known. This type of material is not rated as a duct for passing through or behind walls. We recommend installing metal dryer ducting, and seal the connections with foil tape designed for "heated" applications.

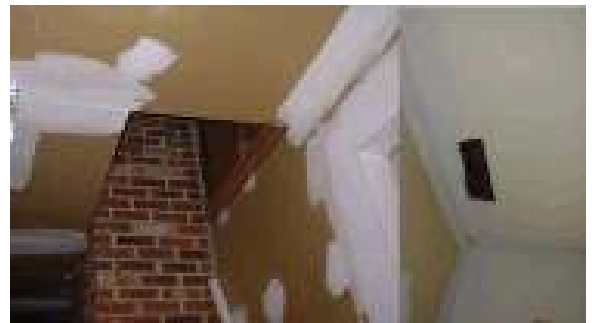
[SC] **Safety Concern** As discussed during the inspection, the fire wall is incomplete. In order to complete it, the following areas need to be sealed with sheetrock: the crawl opening beneath the laundry area, that attic hatch next to chimney, three ceiling holes. We recommend making these changes in the interest of fire safety.

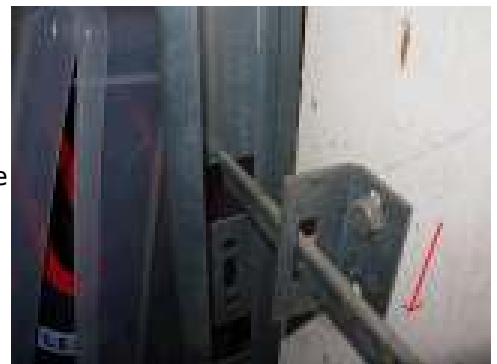
[CR] **Corrections Recommended** [MR] **Maintenance Reminder** It was noted that the security latch was not working as designed. We recommend making the minor adjustment to correct this condition. See photo.
