# T1 REPORT

91 Fairway Road, Haymarket VA 20169.

Colonial Style Home. Approximately 3950 Sq. Ft. 1 Year Old; 2 Story; Finished Basement.

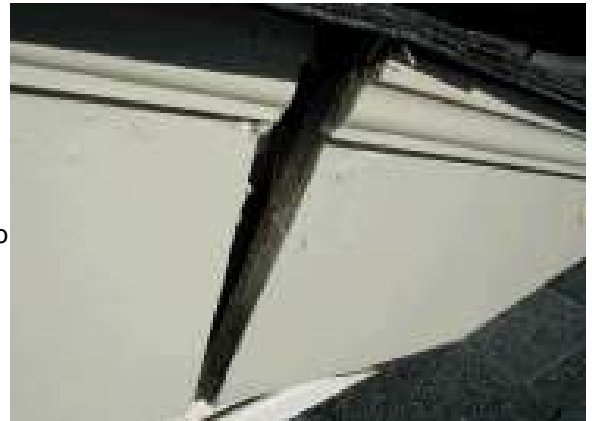
[CR] A section of rake trim is loose/out of place. It appears that the area does not have an adequate nailer. Recommend installing nailer and secure again. See photo.

[MR] The trim board is a composite material that requires paint (especially along the lower drip edge). It was noted that some of the paint in this important area is "thin". This is a reminder to perform proper maintenance as needed according to the manufacturer's specifications.

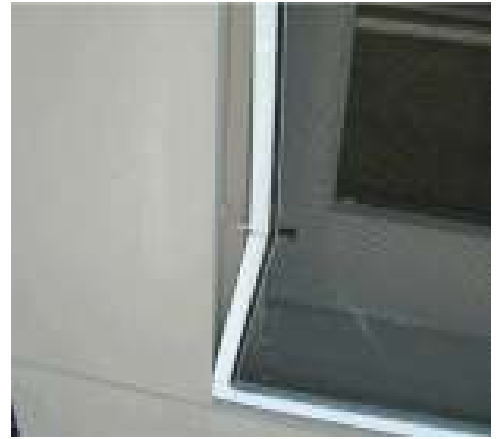
[CR] Noted one damaged screen in front second floor window (guest room).

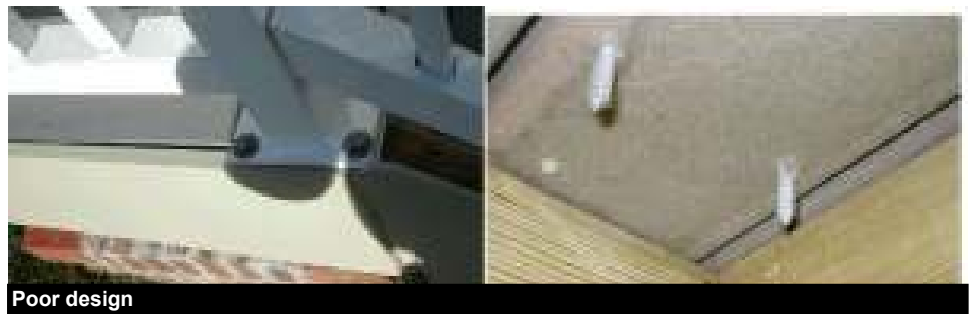
[CR] While the guardrail configuration was functional at the time of inspection, the technique for anchoring the guardrail posts is outside generally accepted carpentry standards. See photo's. Many of the bolts are being held in place in the seam of the frame and the trim (which has also created cosmetic irregularities).

Composite decking boards are not designed to provide structural support as shown here. We recommend having a licensed decking contractor evaluate further and make repairs in the interest of the long term integrity of this railing system.

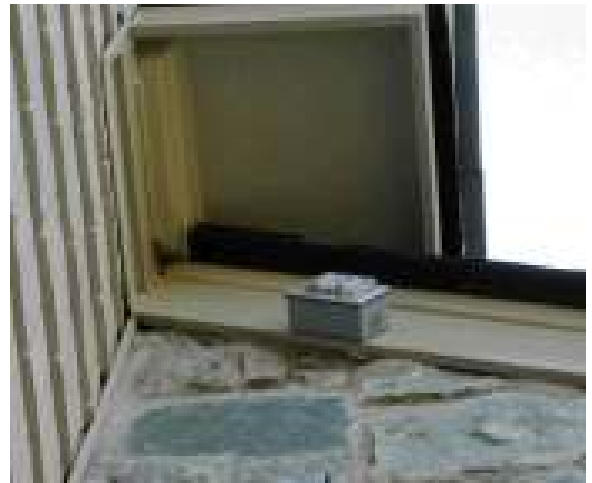
Two exterior electrical outlets were noted in the front of the home under the eaves.

[SC] Modern standards call for GFCI protection for ALL exterior outlets (except for those dedicated to de-icing equipment). If these outlets are intended for exterior lighting, GFCI protection would be highly recommended.

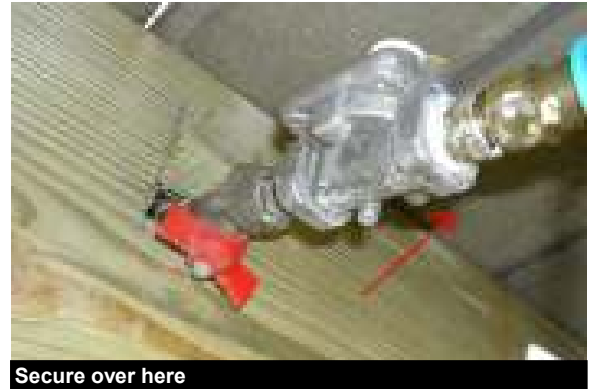
[SC] The line/valve assembly supplying gas to the deck barbeque should be secured. This stainless steel supply line is designed to be flexible for ease of installation; but should be secured once set in place.

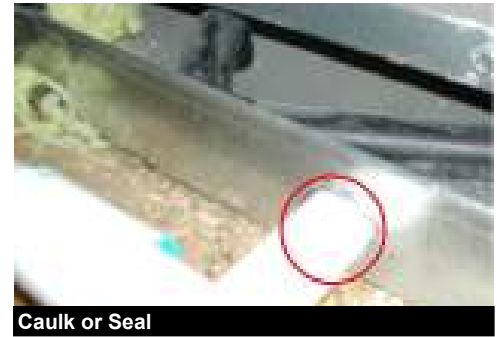
The visible areas of the condensate drain line appeared functional. [CR] The secondary drain system installation was not completed. The line connection to the pan needs to have a water tight seal. As currently configured, should the primary drain line become blocked, water filling the pan could leak out and cause damage to interior spaces. See report photo. We recommend correcting this condition.

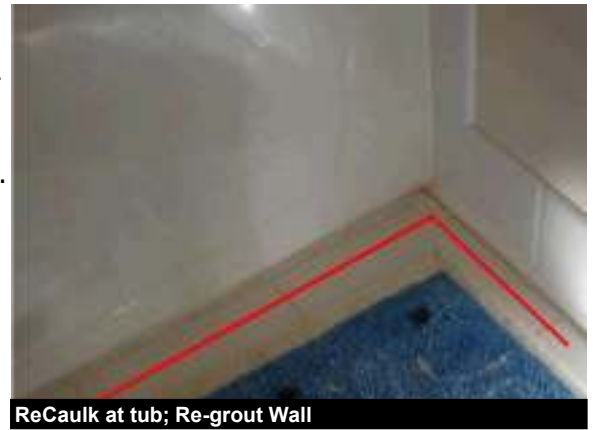
[CR] The water tight nature of the seam along the floor has been compromised. See report photo. This is a critical seam for moisture control, and it is important that it remain intact. We recommend regular maintenance as needed. We recommend caulking between bathtub and floor, and re-grout along the wall.

ReCaulk at tub; Re-grout Wall

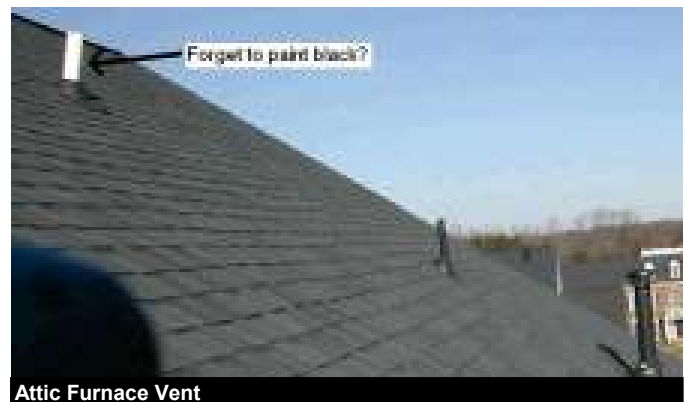
The visible exhaust flue pipes, weather caps, and vent pipes appeared functional.

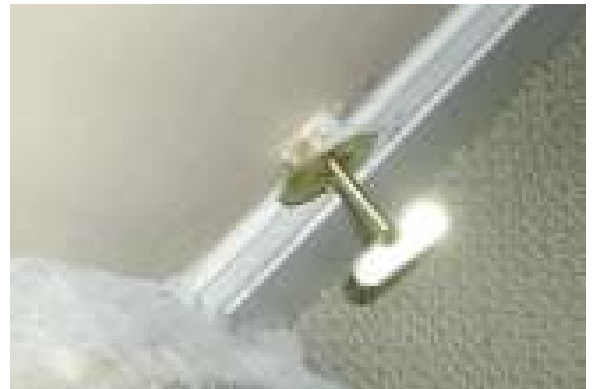
[CR] The wall gas valve flange is not installed as designed. Should be flush with the wall. We recommend correcting this condition.
