T1 REPORT

200 Main Street Court, Manassas VA 20110.

Colonial Style Home. Approximately 3500 Sq. Ft. 20 Years Old; 2 Story; Finished Basement.

John Woods, AII Certified Inspector #01469.

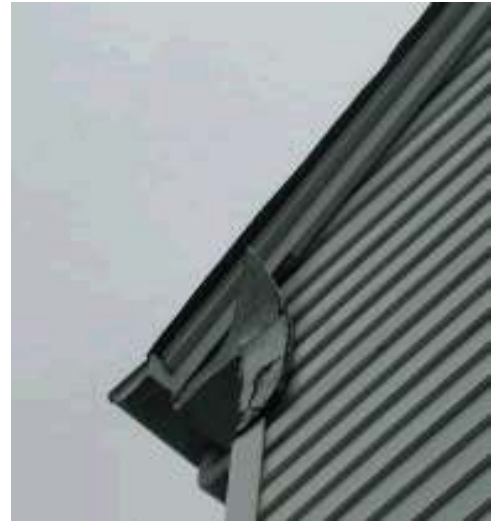
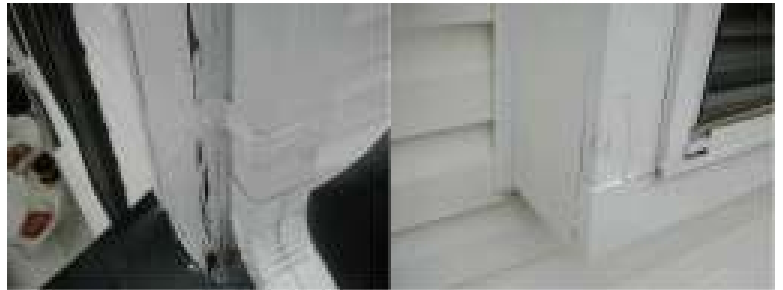
[CR] Varying amounts of moisture deterioration/rot were noted on the homes molding and trim. Some damage can be covered with paint - Some should be replaced. See report photo.

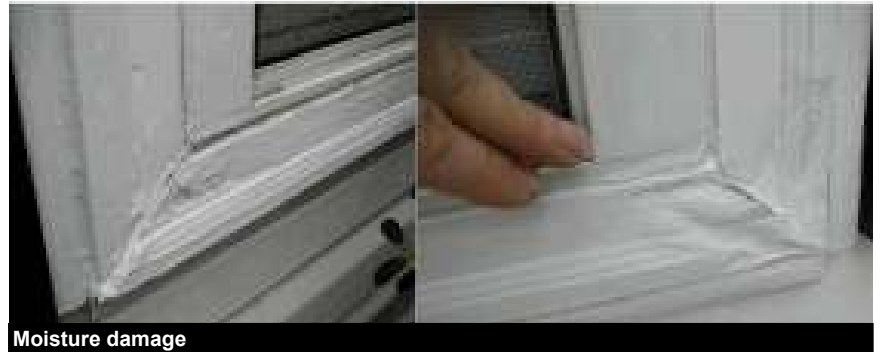
[FE] The windows on the front side of the house had wooden exteriors. A varying amount of moisture damage/rot was found. See report photos. We recommend consulting with a window professional as to the scope of service recommended at this time.

Moisture damage

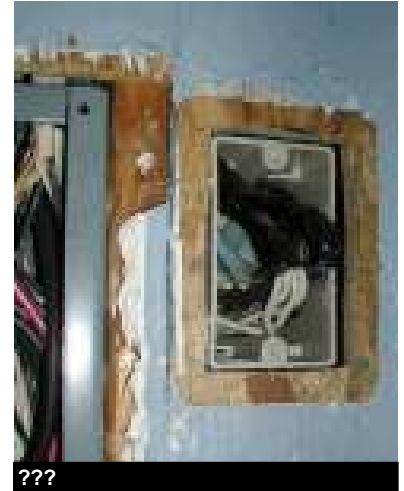
[FE] The plastic junction box next to the panel contained spliced conductors (black found to be "hot") with multiple wires appearing to be sharing wire nuts (an unusual condition). The purpose of this wiring was unknown. Tracing the source of these wires is beyond the scope of this inspection. We recommend that an electrician evaluate and approve this condition for safety.

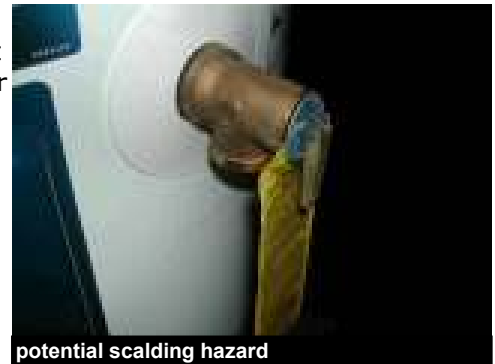
[SC] The temperature and pressure (T&P) relief valve's discharge line was missing. We recommend installing an approved discharge line that extends to within 6 inches from the floor. Many home centers now offer a threaded pipe just for this application. This is a simple repair for any homeowner.

potential scalding hazard

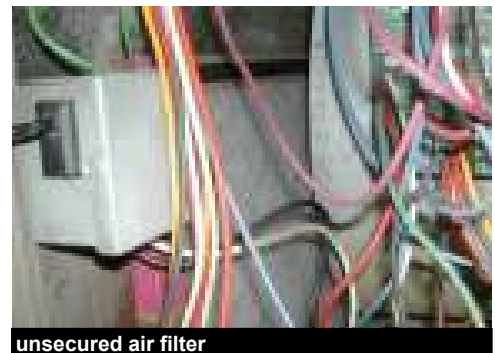
Disposable, found inside the air handler cabinet. [MR] No clips or slot were found to secure the filter in place, allowing air flow to bypass the filter. We recommend correcting this condition.

unsecured air filter

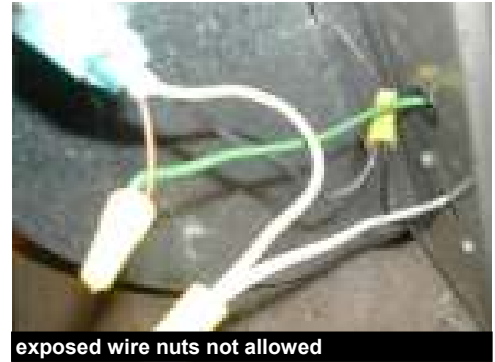
[SC] Some electrical connections in the power supply line to the furnace were not enclosed within a junction box as required. See report photo in the Heat section of the report. We recommend correcting this condition.

Corrections needed, as described in the Electrical section of this report.

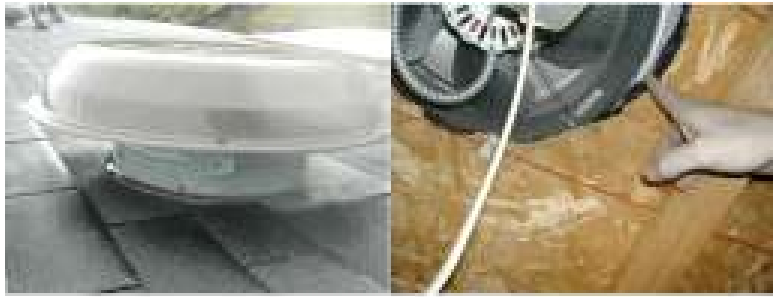
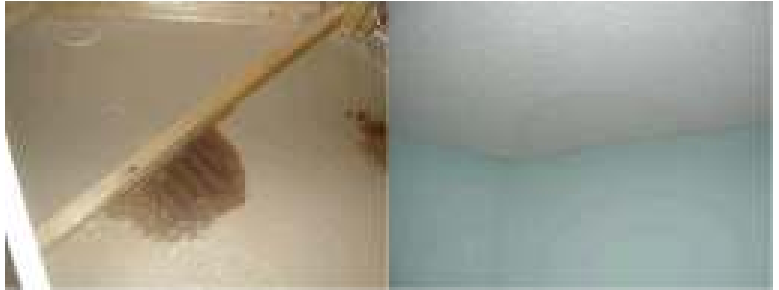
[CR] Yes. The attic roof vent closest to the hatch was allowing water to drip in. See report photo for area of leak and its result. We recommend correcting this condition.

No real damage to sheetrock yet. Cosmetic remedy = paint.

L to R: from above, below

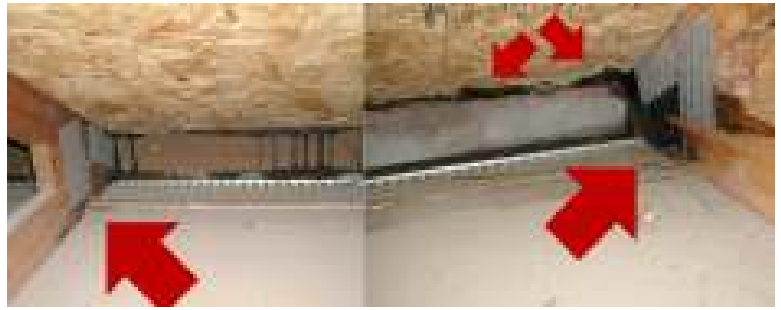
[CR] Yes. There was some minor dripping into the soffit at the front side of the garage roof. See report photos. Some moisture staining was noted on some framing rafters, but no real deterioration was present. We recommend correcting this condition to avoid moisture damage to structural components.

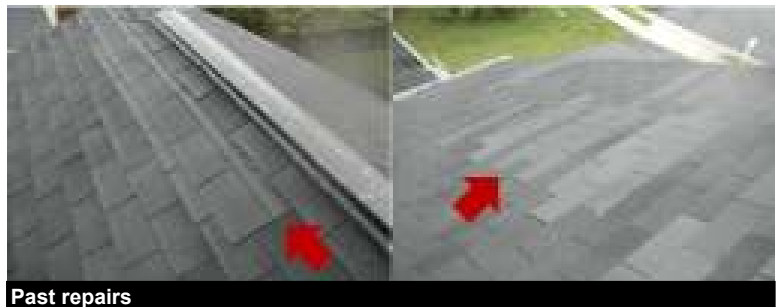
Past repairs

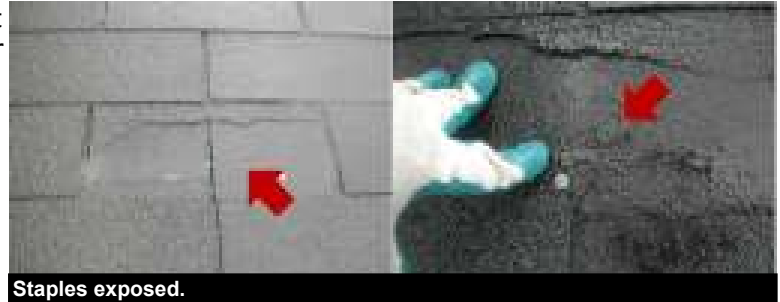
Even though a previous owner had indicated that the roof surface had been replaced, the inspector found no evidence to confirm that this is not the original roof. With that in mind, it would appear that the materials are "older". The condition of the comp shingle's surface aggregate was good. A moderate amount of wind damage, where parts of shingles were partially or completely torn was noted. The seller indicated that some wind damage was repaired. Some face nailing was noted.

Staples exposed.

Overall, we found the roof surface functional with the exceptions described in the Attic section of this report. [MR] We recommend localized repairs as needed. However, as we believe the roof is advancing in age, we recommend budgeting for its eventual replacement sometime within the next few years.

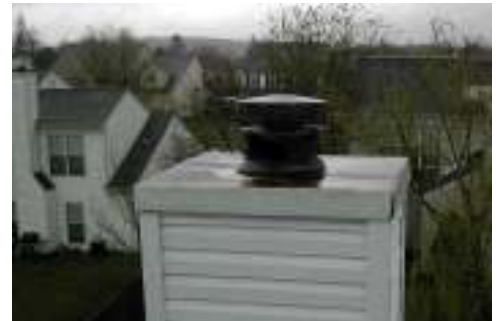
Type: Chimney is a framed chase with siding exterior, and with a metal flue. It was noted that the metal cap had surface rust, a common condition. We recommend addressing this at the time of the next roof replacement.

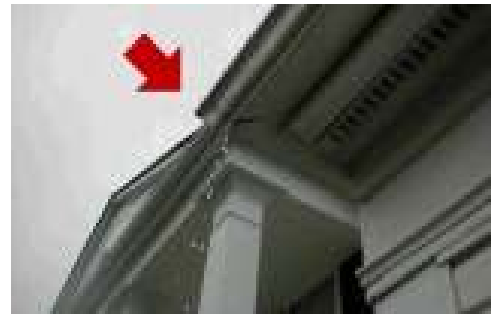
Good. [CR] One corner seam was leaking and should be repaired by sealing over the area with gutter cement. See report photo.

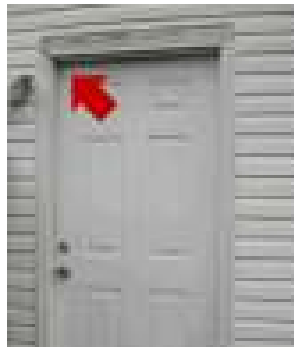
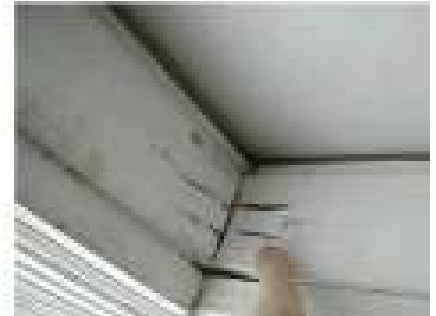
[CR] The wood trim above and around the door had evidence of moisture damage. See report photos. We recommend correcting this condition. See report photos.

Damaged frame molding

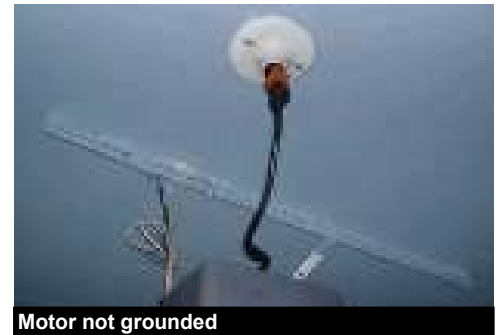
[RU] Screwshell lamp holders are not approved for powering anything except light bulbs. We recommend upgrading to a tradition 3 prong receptacle.

Motor not grounded
