T1 REPORT

20100 Pembroke Court, Sterling VA 20165.

Colonial Style Home. Approximately 2700 Sq. Ft. 13 Years Old; 2 Story;

John Woods, AII Certified Inspector #01469.

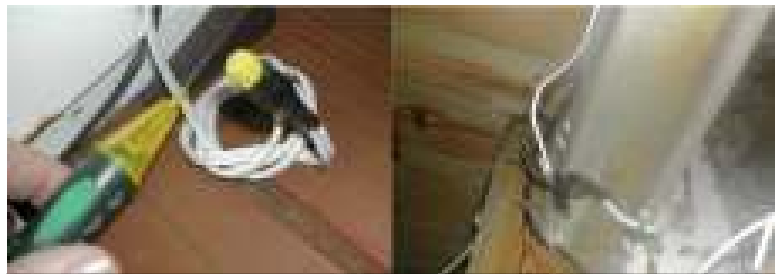
[SC] A set of exterior lights were installed and powered by a plug in cord. The wiring appears to be amateurish and is potentially hazardous (an exposed live termination, an exposed splice). We recommend removing this lighting, or having a licensed electrician rewire it according to current safety standards.

Incorrect wiring

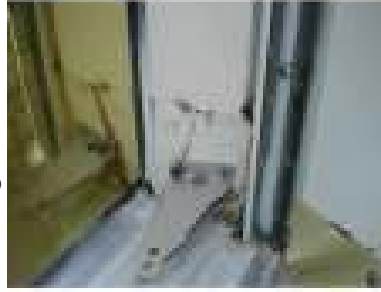
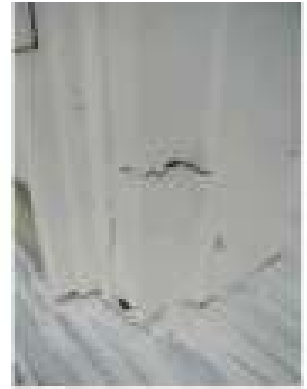
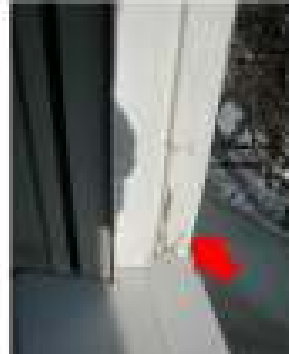
Top/Down- front door; window trim

Most of the wood molding/trim was in good condition. There were a few places found to have some deterioration/rot:

-A few inches of window trim on the lower left side - second floor middle bedroom.

We recommend replacing damaged wood prior to the next painting.

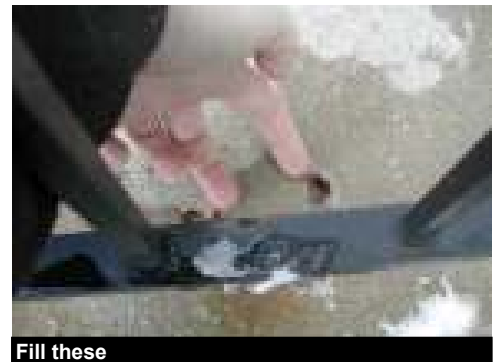
Concrete. [MR] A couple of holes were noted in the concrete. See report photo. To protect against spalling from freeze/thaw forces, we recommend filling these holes with using materials designed for this purpose.

Fill these

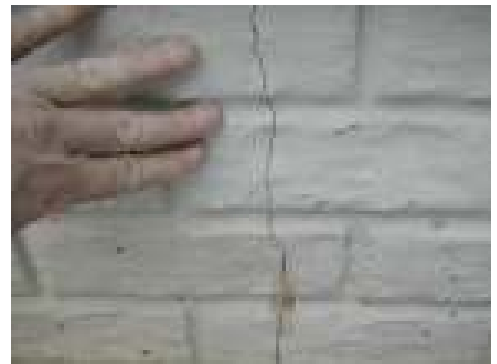
Hairline cracks in the foundation were noted. The cracks were vertical, less than 1/8 " thick and had no vertical or lateral displacement. No action needed. We always recommend that all foundation cracks be monitored. If ongoing movement is ever observed (a change in appearance), then further evaluation by a foundation specialist should be sought.

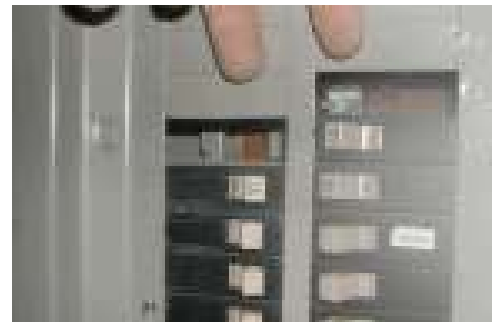
The electrical service is a 120/240 volt system, rated at 200 amperes. The disconnect type = Circuit breakers. The circuit breakers/fuses in the panel were labeled. The accuracy of the labeling was not verified. [SC] There were missing twist-outs/unused breaker slots in the panel. This is a potential safety hazard. We recommend that an electrician install fill plugs designed to cover such openings.

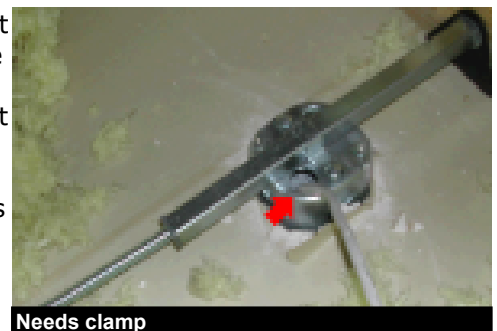
Copper and aluminum. Non-metallic sheathed cable. The branch circuit wiring appeared functional. [SC] A few receptacles were found to have improper wiring in the form of:

- open ground connections in the basement next to the stairs (see report photo);
- reversed polarity in dining room receptacle
- basement bathroom receptacle listed below in GFCI Device section was incorrectly wired as well as lacking GFCI protection

[SC] The master bedroom ceiling fan junction box (in attic) was missing a cable clamp. We recommend correcting this condition.

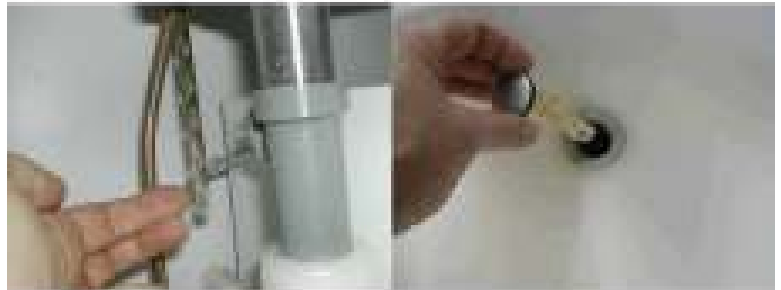
[CR] The basin (right side) overflow drain was slow/blocked, and did not prevent water from flooding over the rim. We recommend correcting this condition.

Needs repair

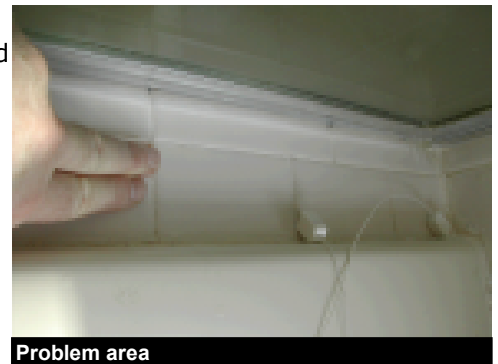
[MR] Some tiles sounded hollow when tapped upon, indicating they are no longer bonded to the top deck. See report photo. We recommend re-attaching loose tiles and resealing with grout/caulk so that moisture cannot intrude into interior spaces (and/or keeping the top deck reasonably dry).

Problem area

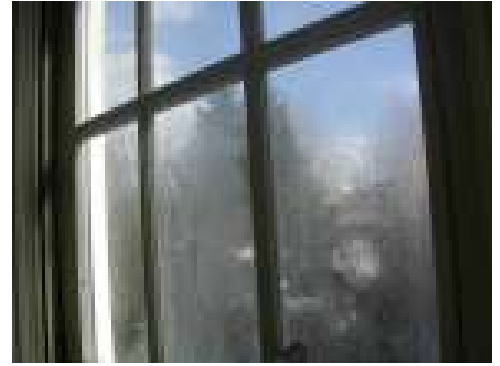
[CR] This room has one window with broken or damaged seals, which was obvious. Another window over the tub appeared to have stains starting to develop between the panes. We recommend having a window professional evaluate and replace the damaged panes.

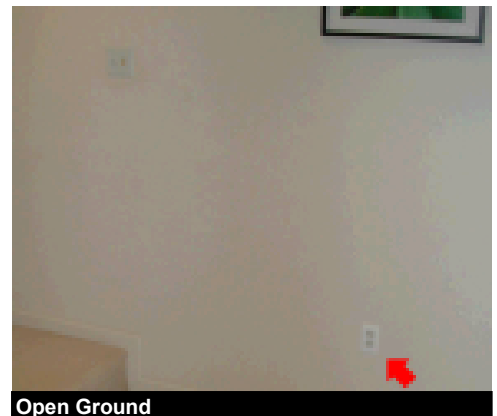
Condition: Good, with the exception noted in electrical section. See photo.

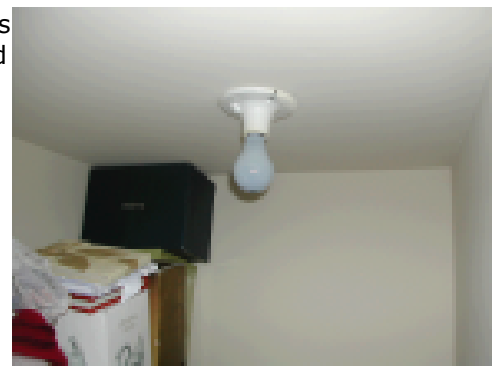
[RU] [SC] There was an exposed incandescent light bulb in the clothes closet. Building codes now require that these bulbs need to be enclosed as a precaution against fire. We recommend upgrading the light fixture in this closet (to a recessed, or enclosed light) for increased safety. If not, a cooler burning fluorescent bulb would be preferred to the incandescent bulb.

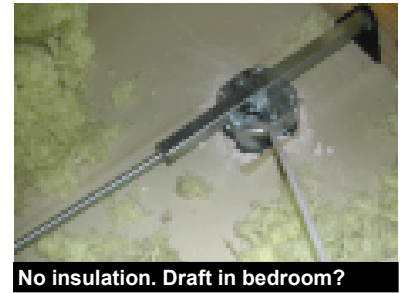
Materials: Blown in fiberglass. R Rating is about 3 per inch of thickness. Total thickness: Mostly between 8-14 inches on average. Note: Insulation in some areas has been disturbed in a way that has lowered the R value in those areas. We recommend repositioning the piled up insulation into low areas to restore a uniform insulating barrier.

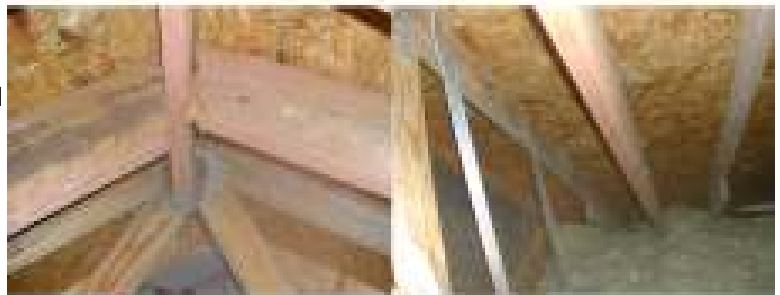
Some unusual framing was noted around the fireplace flue. It appears that the original truss framing was altered during construction to accommodate both the fireplace flue and the gas appliance flue. Additional support framing around the altered area was in place and appeared to be functional.

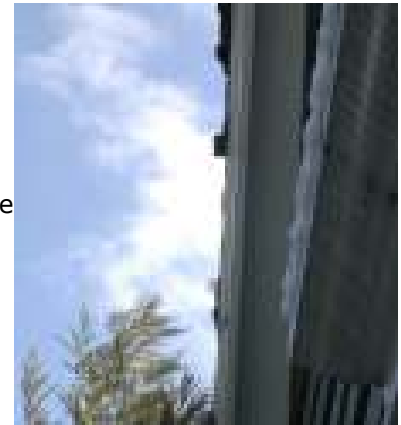
[CR] Some contact damage from nearby trees was noted to overhanging roof shingles. See report photo. Due to snow cover, we could not assess the impact of this damage to the roof system, but suspect minor damage if any. We recommend monitoring the area once warmer weather arrives. If any wood or roofing paper is exposed, make repairs by either replacing damaged shingles, or placing aluminum flashing between/beneath shingles where needed. The tree branches near the roof should be trimmed back so that they will no longer contact the roof during high winds.

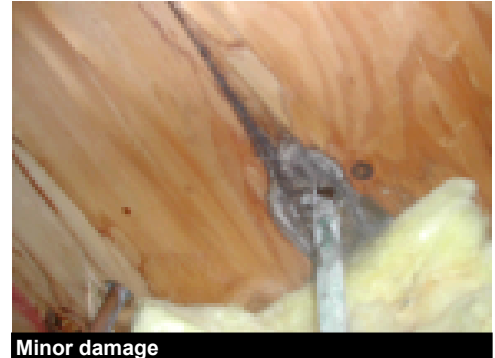
[CR] The cold supply faucet/hoseconnection had a small leak that appears to have been active for some time. See report photo of moisture staining seen from below in the basement. We recommend correcting the leak (strongly suggest replacing both supply hoses with stainless steel hoses).

Minor damage
