T1 REPORT

10 Horse Farm Drive, Clifton VA 20124.

Colonial Style Home. Approximately 2347 Sq. Ft. 29 Years Old; 2 Stories with finished basement apartment. 3 Car Garage. Swimming Pool.

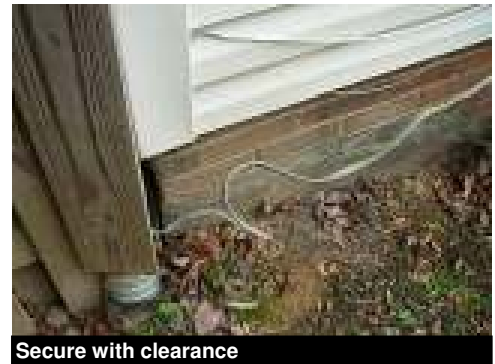
[SC] Safety Concern The conduit enclosing the 240V pool equipment conductors was broken exposing those wires to possible mechanical damage. The UF cable next to it also needs to be protected where it comes out of the ground. (See report photo)

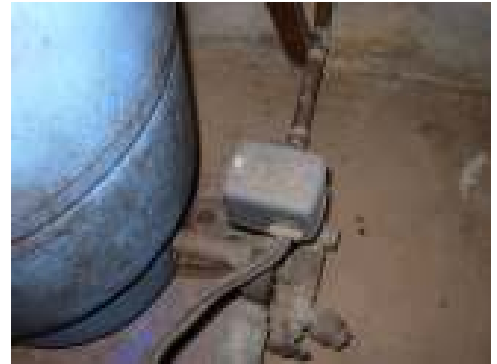
Water supply pressure is determined/controlled by the pressure switch (gray), which signals the well pump to add water to the pressure tank (blue) as needed.

It appeared that the pressure is set to range between 30 - 50 psi. A tank pressure gauge is installed. This gauge does not affect the systems functionality in any way. It is the pressure switch that controls the pump cycle. The system was functional.

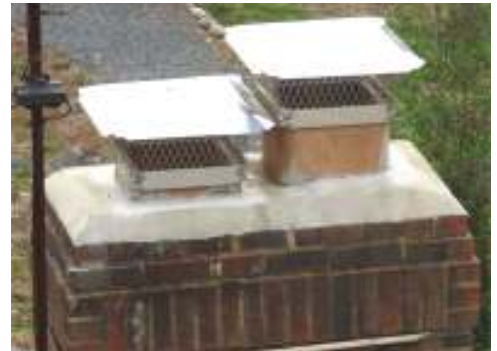
Type: Brick chimney with tile flues. The visible areas of the chimney looked good. Flue caps were installed (looked new).

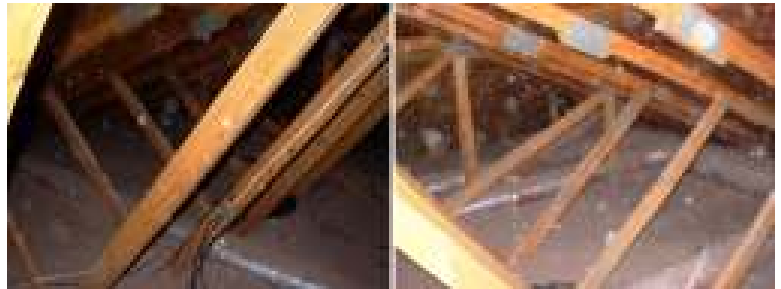
Type: Truss System. Condition: Good. The plywood sheathing was in good condition.
