T1 REPORT

200 Main Street Court, Manassas VA 20110.

Colonial Style Home. Approximately 3500 Sq. Ft. 20 Years Old; 2 Story; Finished Basement.

John Woods, AII Certified Inspector #01469.

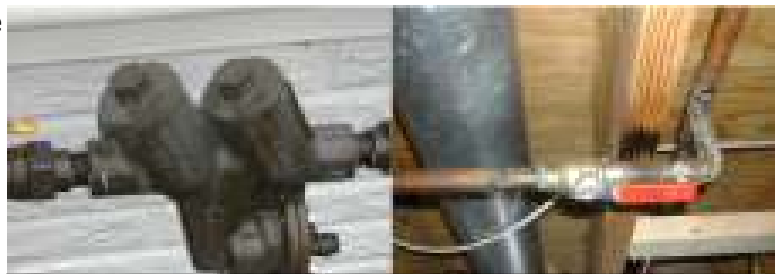
SPRINKLERS

A sprinkler system is installed. Did Not Test. The inspection of sprinkler systems is beyond the scope of this evaluation. It is recommended that instructions and/or demonstration be obtained from the seller.

Cutoffs: outside, inside (basement)

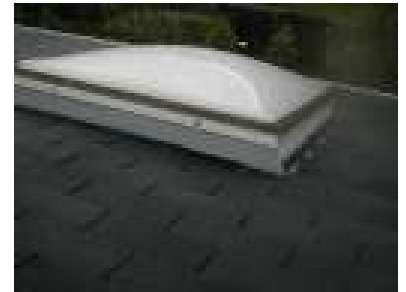
SKYLIGHTS

The skylight was observed from above and below. There was no evidence of prior leaking. Flashing and drainage looked good.
